## A Survey of Thatched Buildings in Scotland

Thatch Survey of Scotland  
2014-15

A photographic survey of thatched buildings in Scotland, surveyed between May 2014 and August 2015 by Zoe Herbert (SPAB Scotland Officer), on behalf of the Society for the Protection of Ancient Buildings.

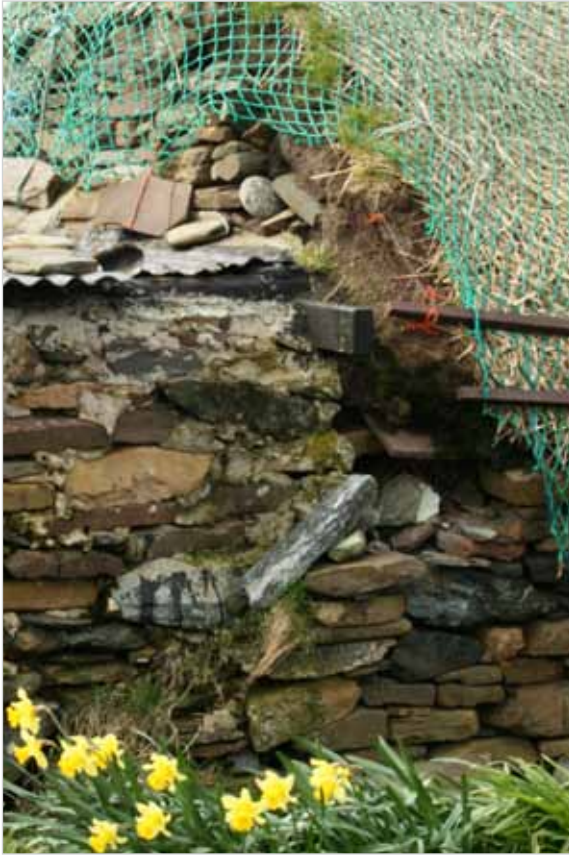
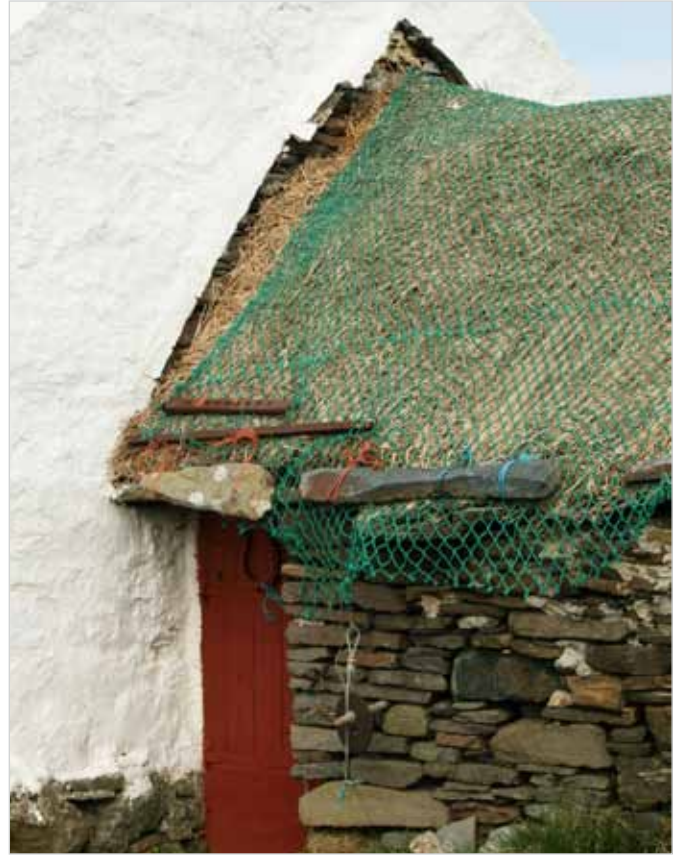
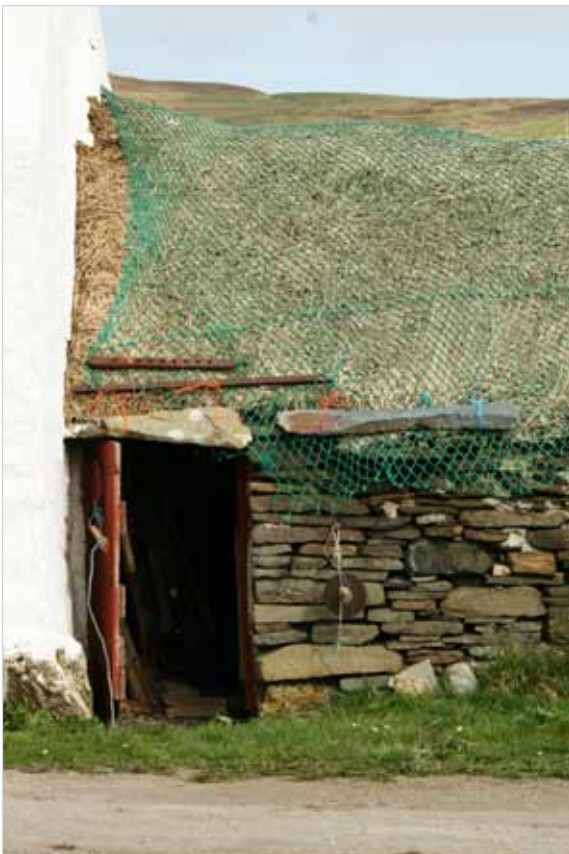
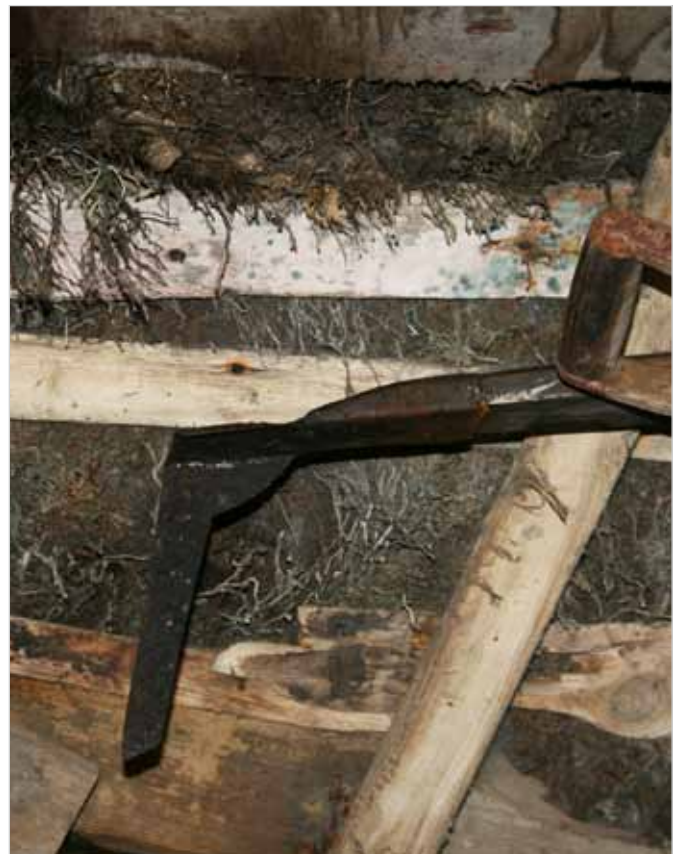
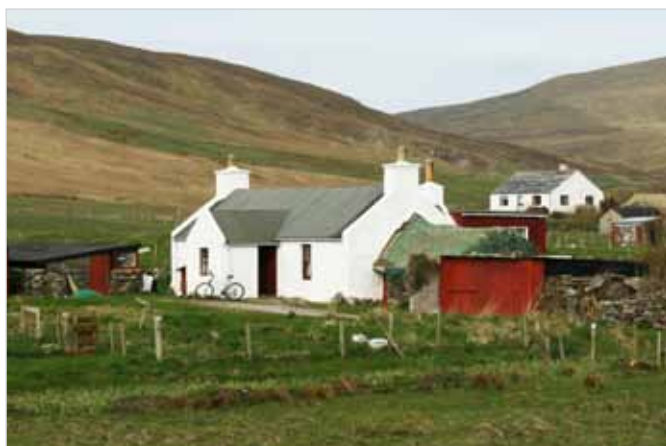
Villians Crofthouse – Shetland Islands

Condition of Thatch: Good

**Additional Notes:** Single-storey flagstone rubble wing adjoining single-storey crofthouse to the north-east gable. Previously all were thatched; however, now only the wing retains its straw-thatched roof, and is currently used as an outbuilding for storage. A top-coat of thatch was last installed in 2014 by the owner of the building. Bale straw from Lerwick was used, however, previously the owner grew straw on his land and used this to thatch the roof. The owner stated that the roof needs a new layer of thatch every year. The layers of straw have been laid upon a underlay of turf, which can be seen through the roof structure internally. The thatch has been netted

with fishing net and weighted along the eaves using stones and metal poles, which have been secured to the netting with string. There is some minor vegetation growth in places and some visible shrinkage in the height of the thatch. Locals stated that traditionally buildings on Shetland were thatched using black oat straw.

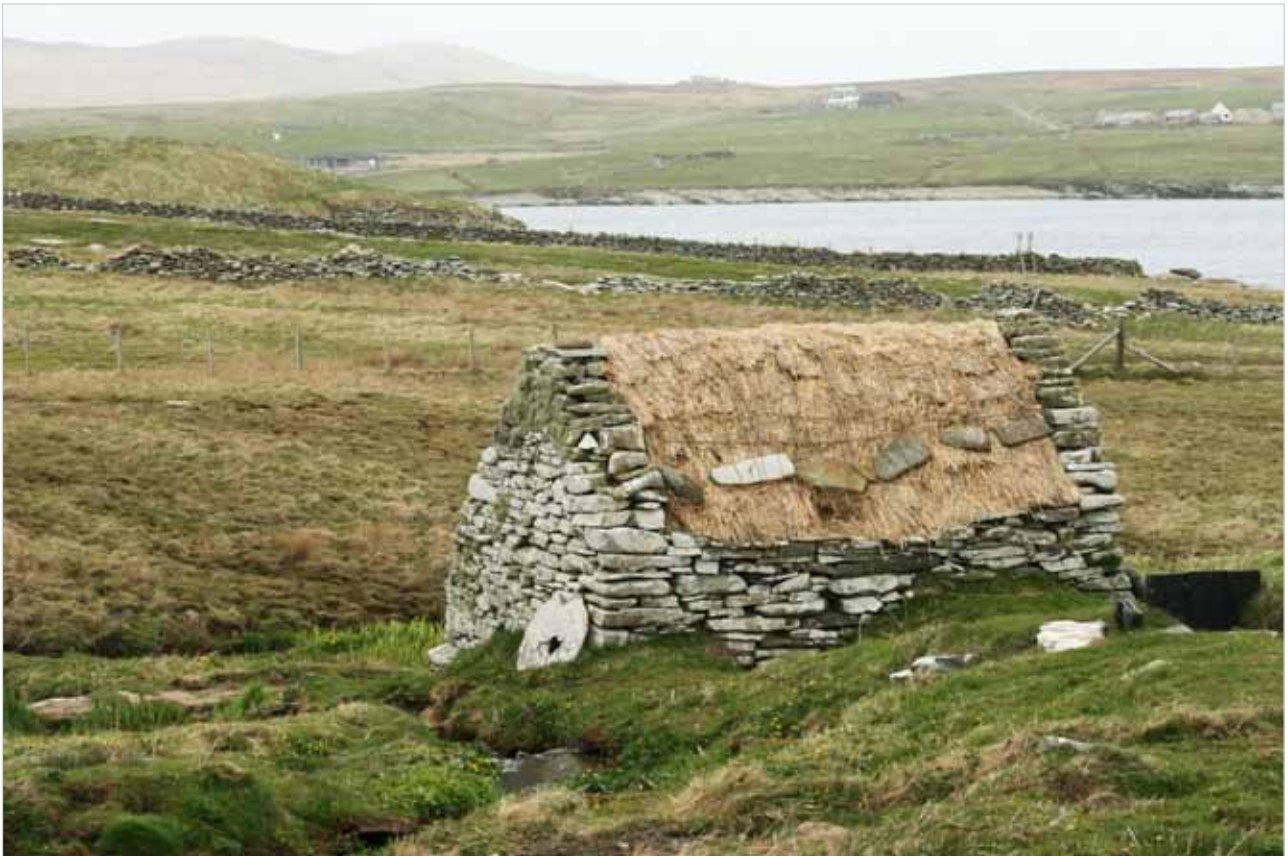
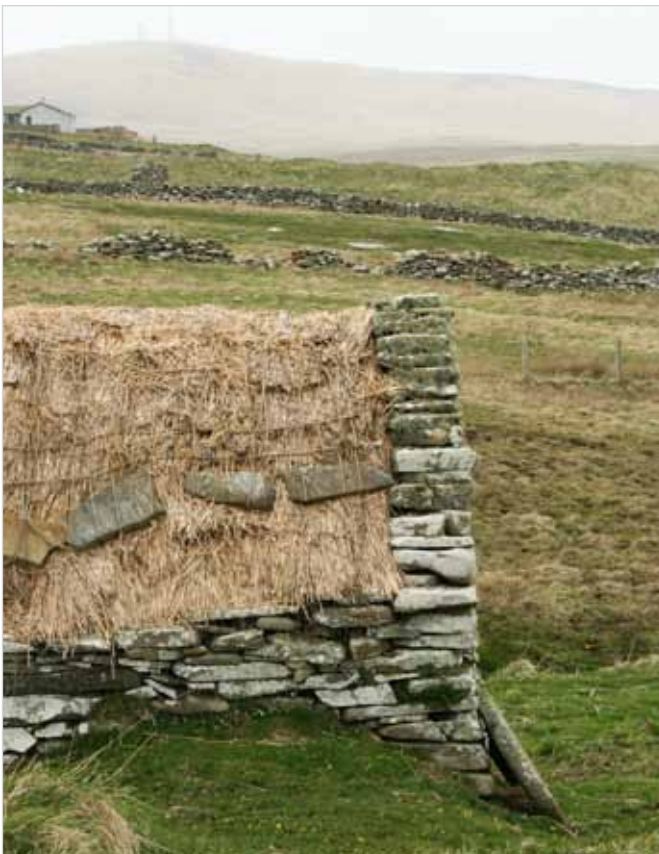
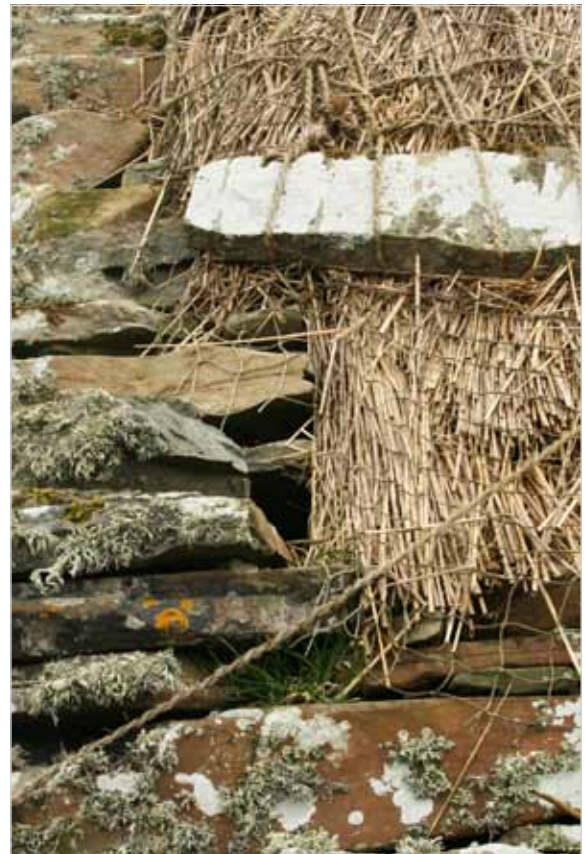
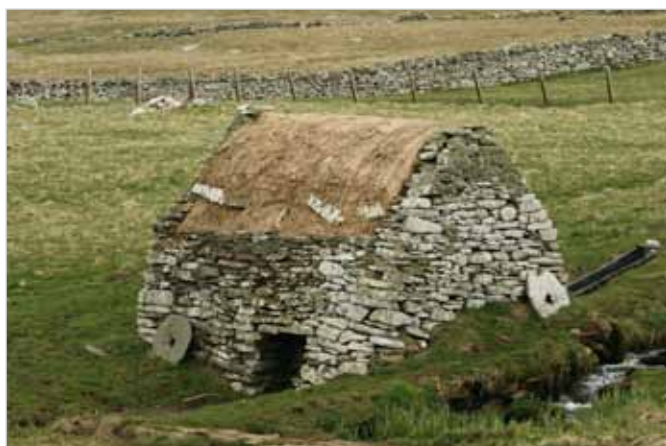
Southvoe Water Mills – Shetland Islands

Condition of Thatch: ..... Fair

**Additional Notes:** ..... Later 19th-century mill, originally one of a group of three mills located along the same burn. The north mill of the three mills at Southvoe retains a straw-thatched roof, whilst the other two mill buildings are now ruins. The mills are associated with the crofting settlement at Southvoe, which is now the Shetland Croft House Museum (also thatched, survey number 194). The mill is now part of, and maintained by, the Shetland Croft House Museum; however, the building is no longer used as a working mill. The thatch is netted using fishing net, which is weighted down using stones tied to the netting with string, placed at about a foot above the

eaves on both the front (north) and back (south) elevations. Whilst the condition of the straw is good, there are a number of small openings in the thatch, along the skews and at the eaves, exposing a small amount of the buildings' interior. The roof is continuously thatched in straw across the ridge.

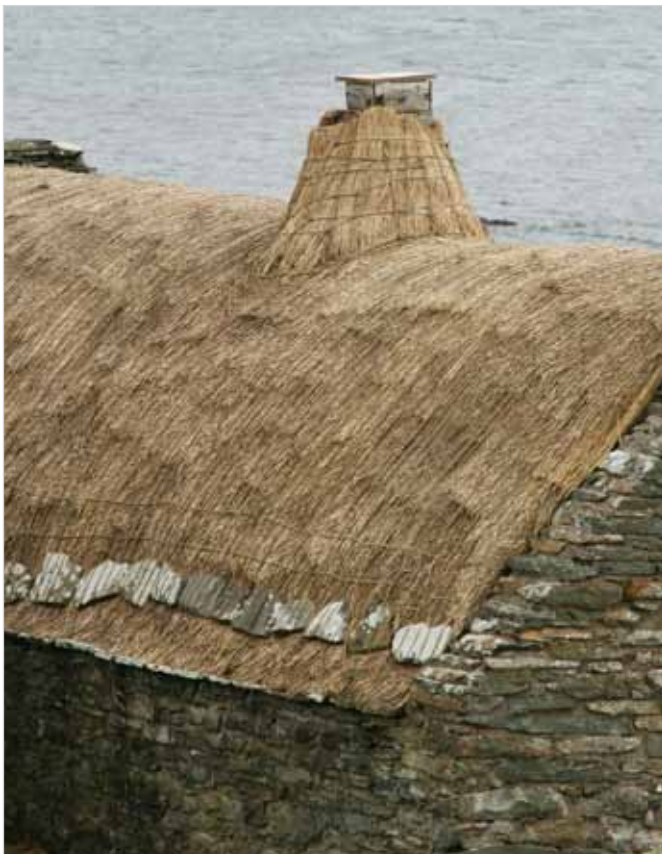
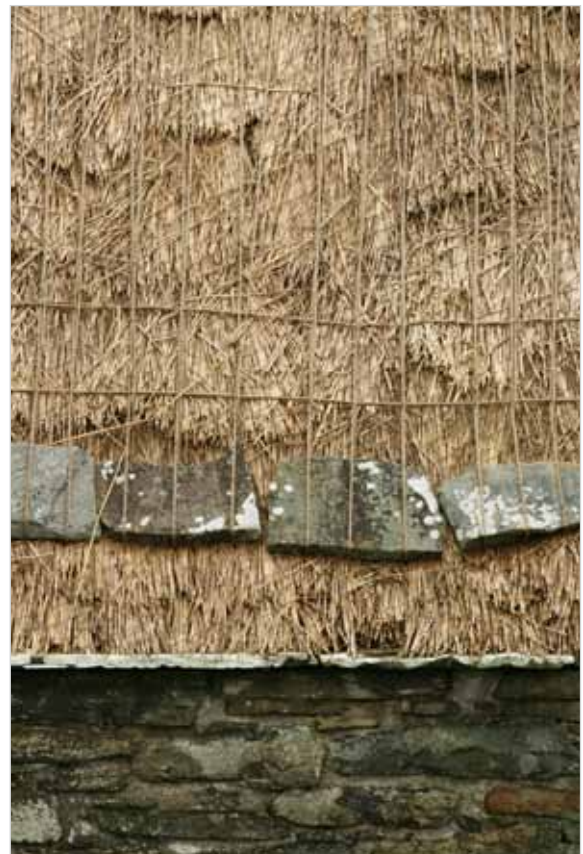
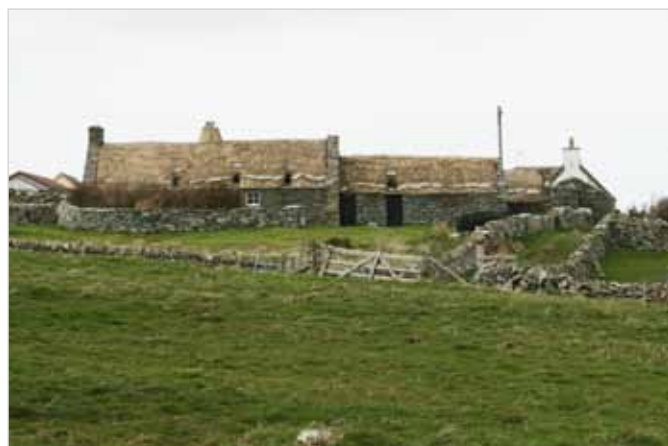
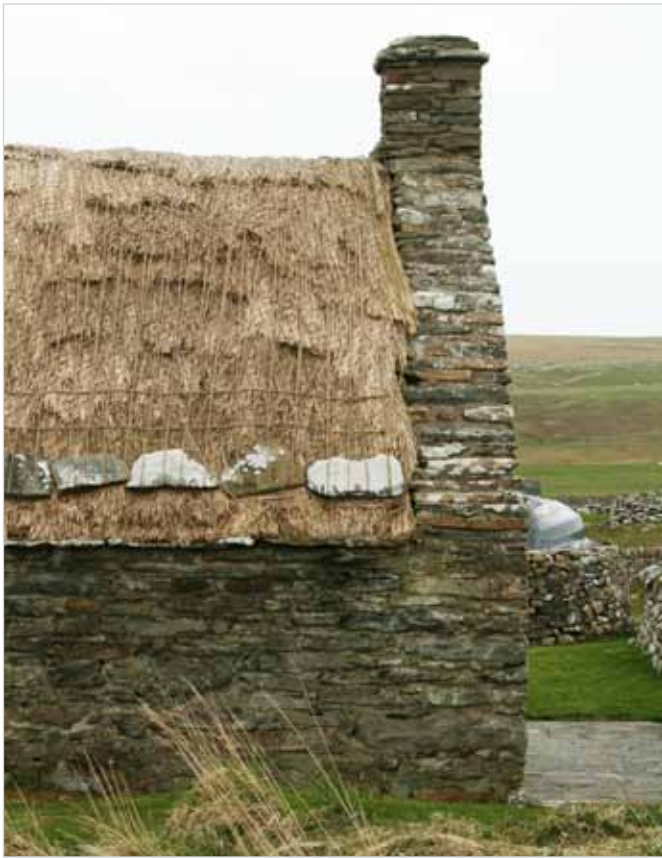
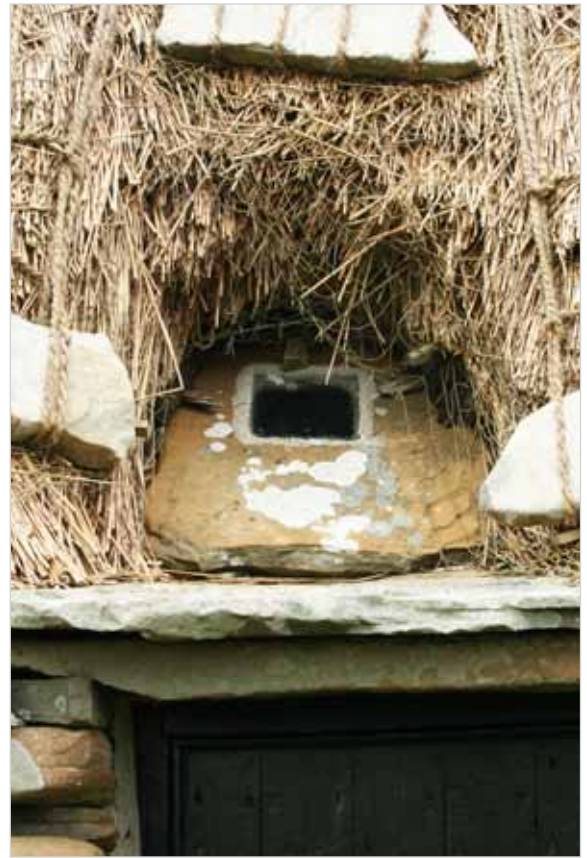
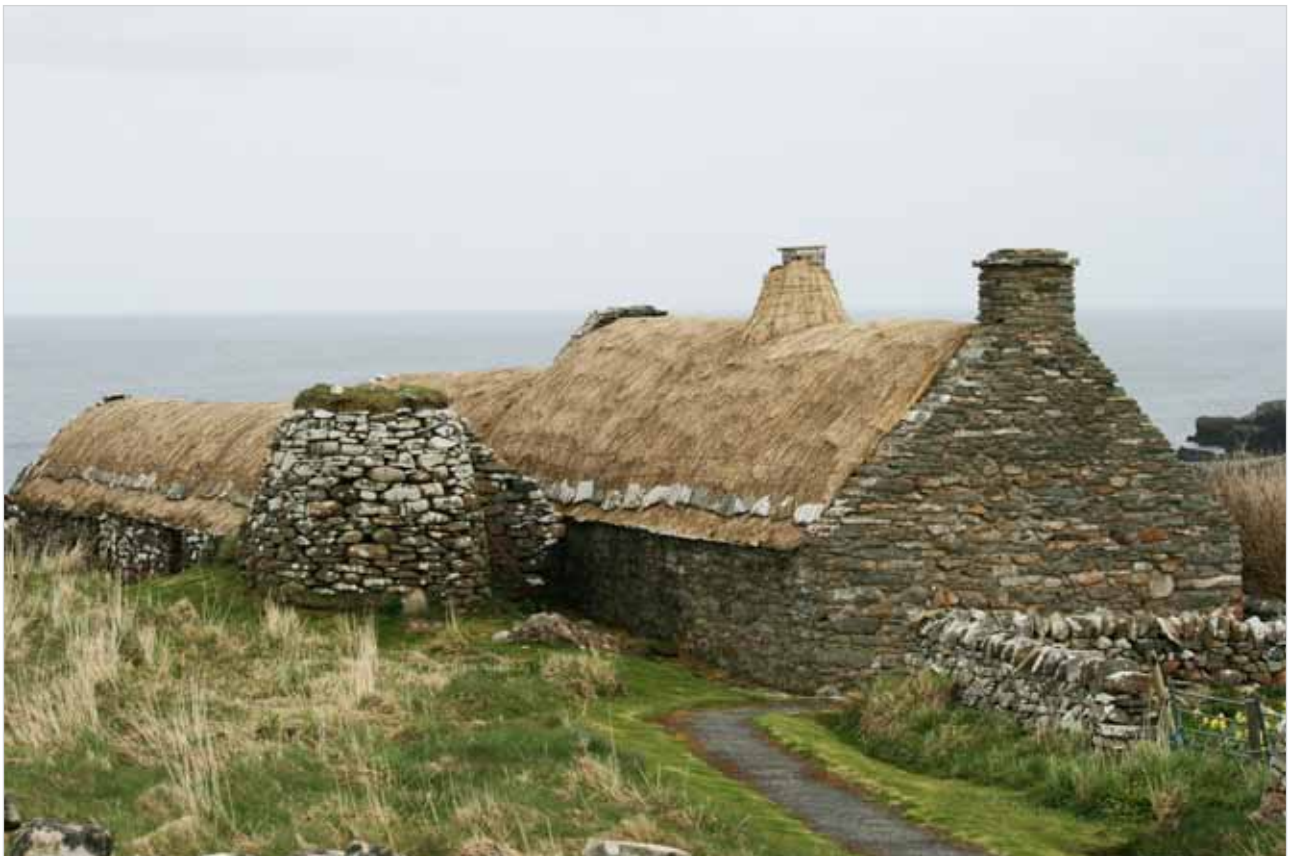
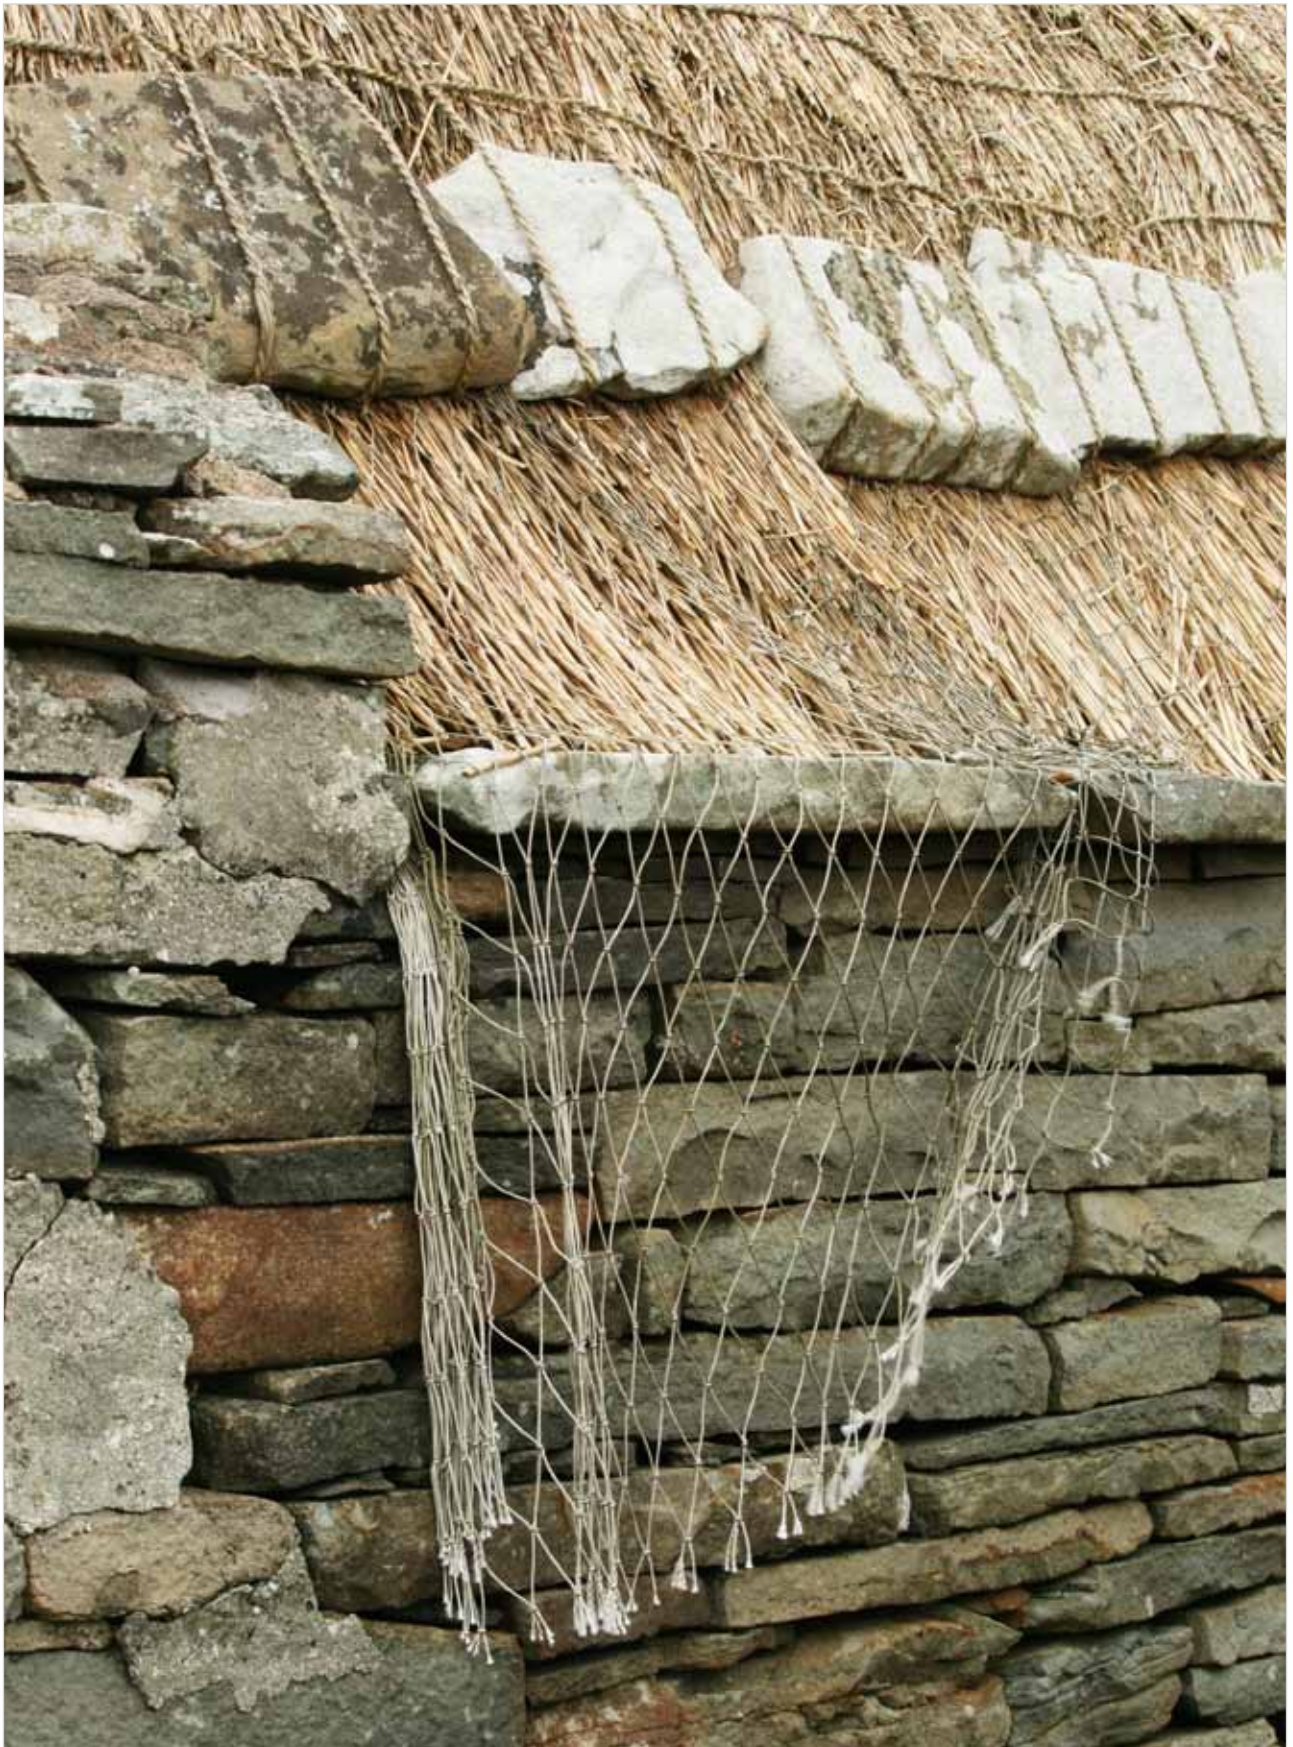
Shetland Croft House Museum – Shetland Islands

Condition: ..... Good

Additional Notes: ..... Circa 1870 group of buildings, now used as part of the Shetland Crofthouse Museum.

..... Rectangular croft building and byre attached, with barn situated parallel to the north. All three buildings currently retain straw-thatched roofs. Situated along the ridge of the main crofthouse, slightly off centre, there is a timber chimney stack that has also been thatched. All three roofs have been netted in fishing net, weighted down with thin ropes that extend across the ridge, and stones tied with rope at around a foot above the eaves and window openings. The thatch on the chimney stack has been tied with string; however, it has not been netted.

..... There are stone slabs along the wallheads of the buildings and the thatch sits flush with the edge of the wallhead, leaving no overhang. The thatch also sits flush with the rubble skewers. A turf underlay is visible within the recessed window openings. The listing notes state it was restored as a museum in the 1970s.

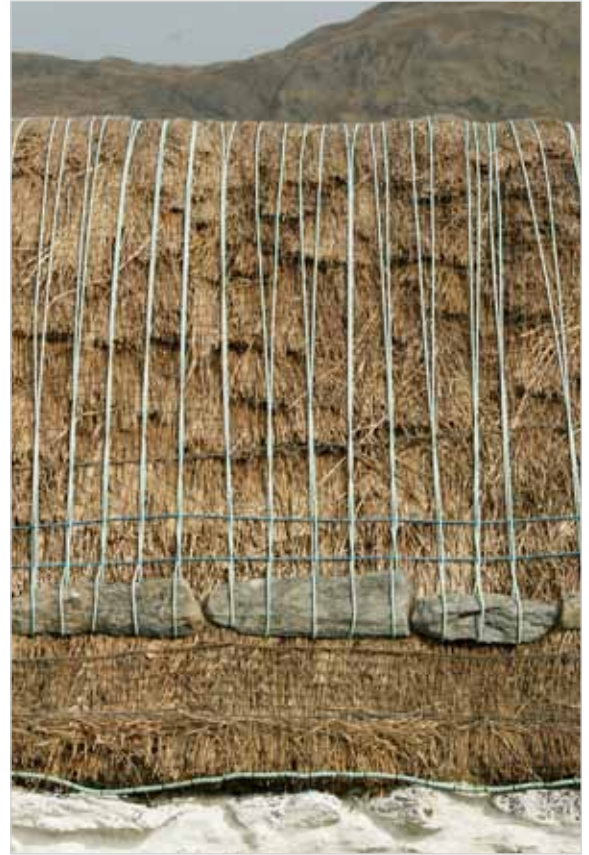
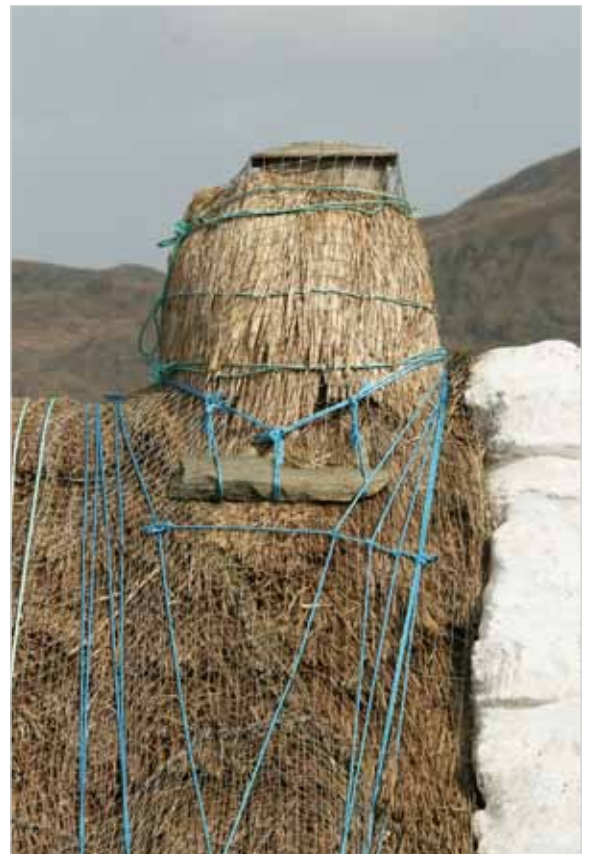
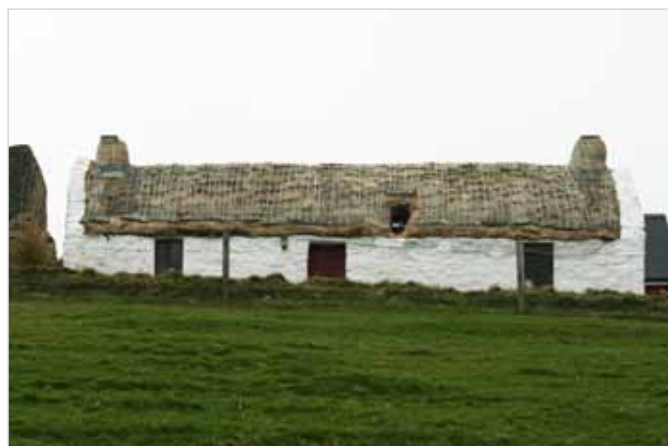
Easthouse Croft – Shetland Islands

Condition of Thatch: ..... Fair

**Additional Notes:** North cottage, part of a group listing of late 19th and early 20th-century crofting settlement currently used as a museum. The south cottage now has a tar-felted roof, whilst the north cottage is listed as having a 'taekkit (*thatched*) roof with linkstanes and cast-iron skylights at eaves; riggin (*ridge*) terminated at gables with *thatched lums*'. The roof is thatched in straw, a traditional thatching material on the Shetland Islands (traditionally black oat straw). The thatch also covers the chimney stacks (*lums*) and continues across the ridge. The thatch is entirely netted using fishing net, which has been weighted with string and stones. The string wraps

around the lums and has been used across the ridge and tied to the stones that sit just above the eaves. The straw appears to be slightly loose in small patches across the roof; however, the roof structure or interior does not appear to be exposed in any way. The roof of the adjoining wing to the west is felted.

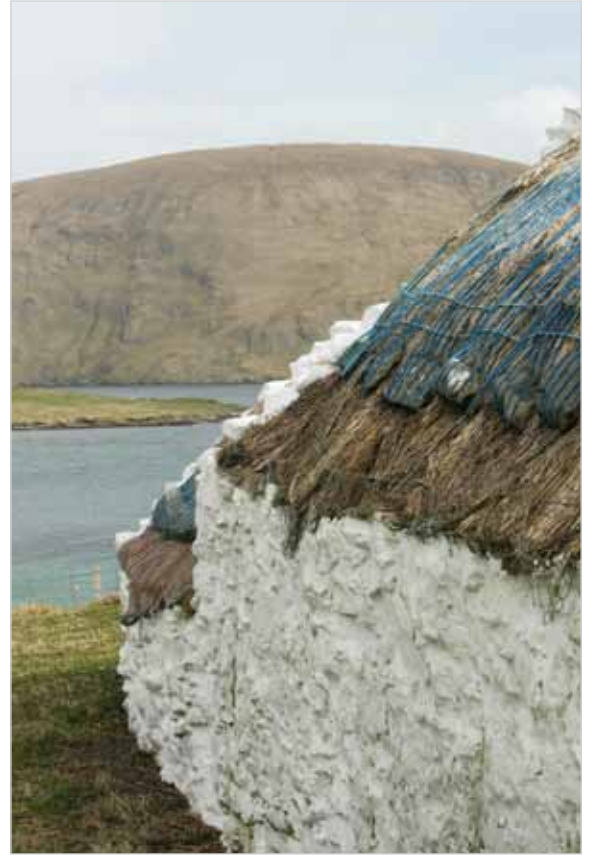
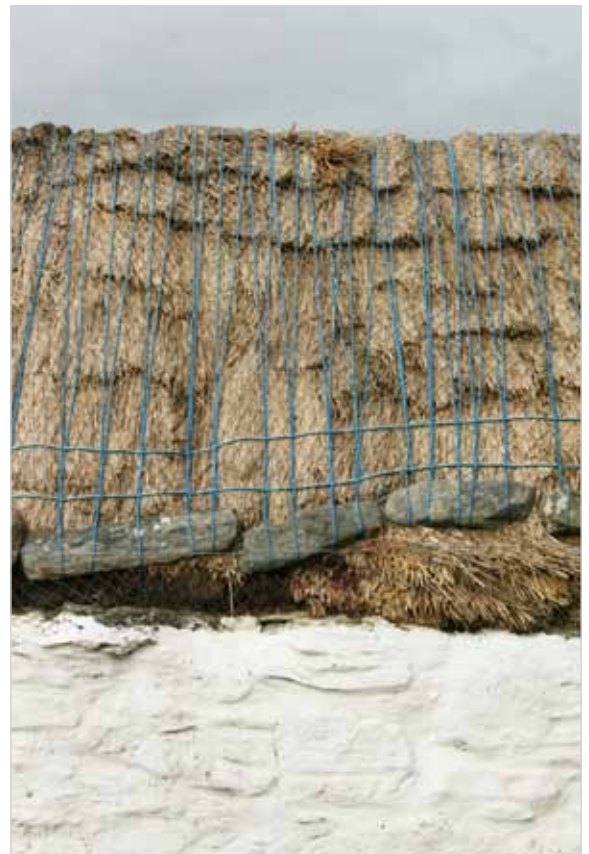
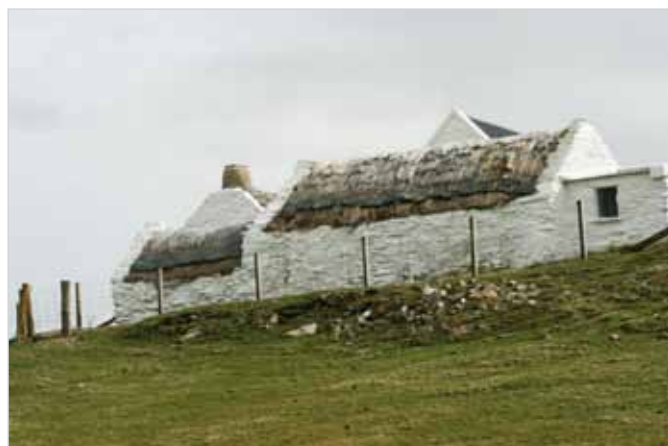
Easthouse Byre and Pig Sty – Shetland Islands

Condition of Thatch: ..... Fair

Additional Notes: ..... Byre and pig sty, part of a group listing along with late 19th and early 20th-century crofting settlement, currently used as a museum. The listing notes read 'a now rare example of a crofting settlement, currently unrestored (1997), with its various outbuildings and thatched roofs surviving'. The listing description states that both the byre and pig sty have a turf roof at the time of listing in 1997; however, they are currently thatched in straw. The straw is held in place by fishing net, which has been weighted by strings that extend across the ridge and are tied to stones that are placed just above the eaves. The straw has become slightly dislodged

and sagging in places, with small sections of a turf underlay becoming exposed in sections along the eaves and down the skews of both roofs. An additional metal wire has been used below the stones to further secure the netting at the eaves. Whilst the adjoining hen house to the west of the byre is listed as having a felted roof it currently has a corrugated iron roof.

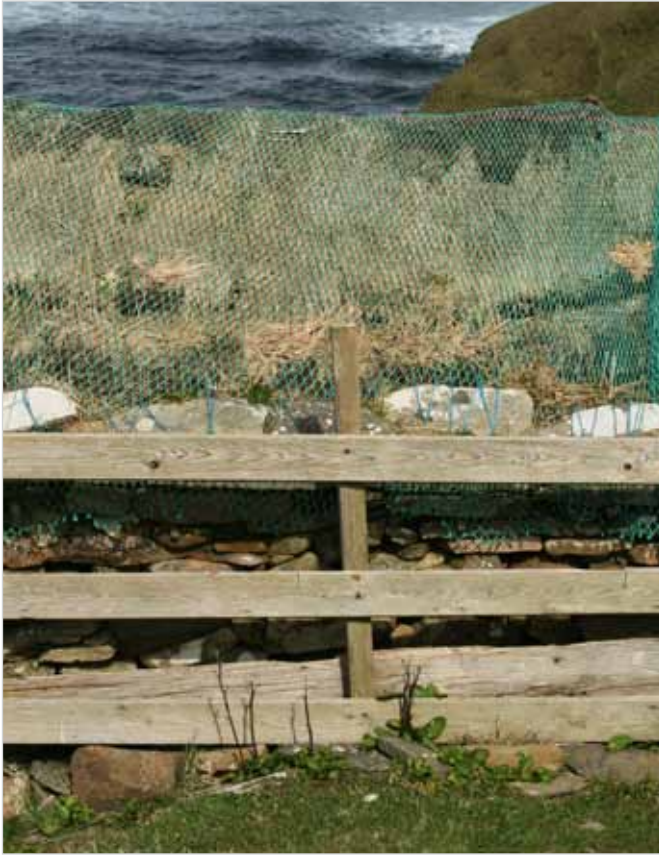
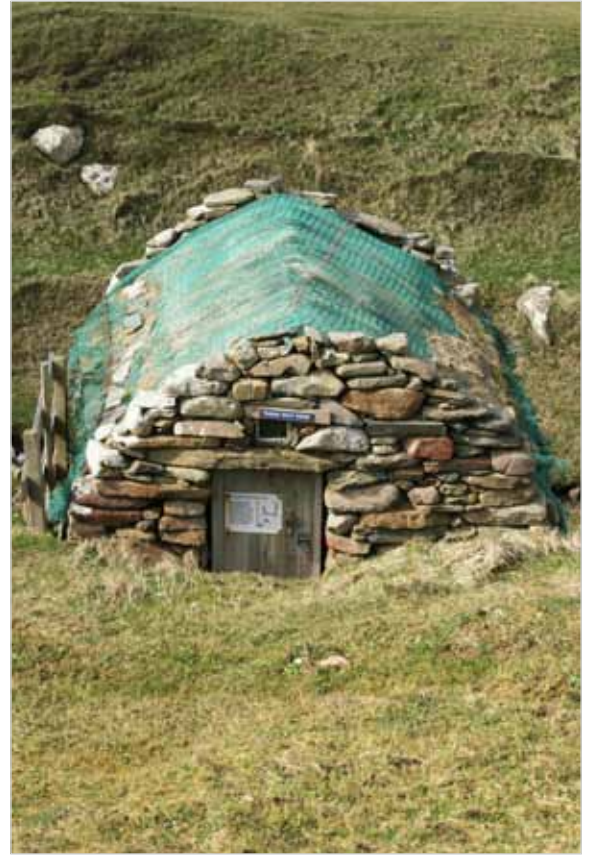
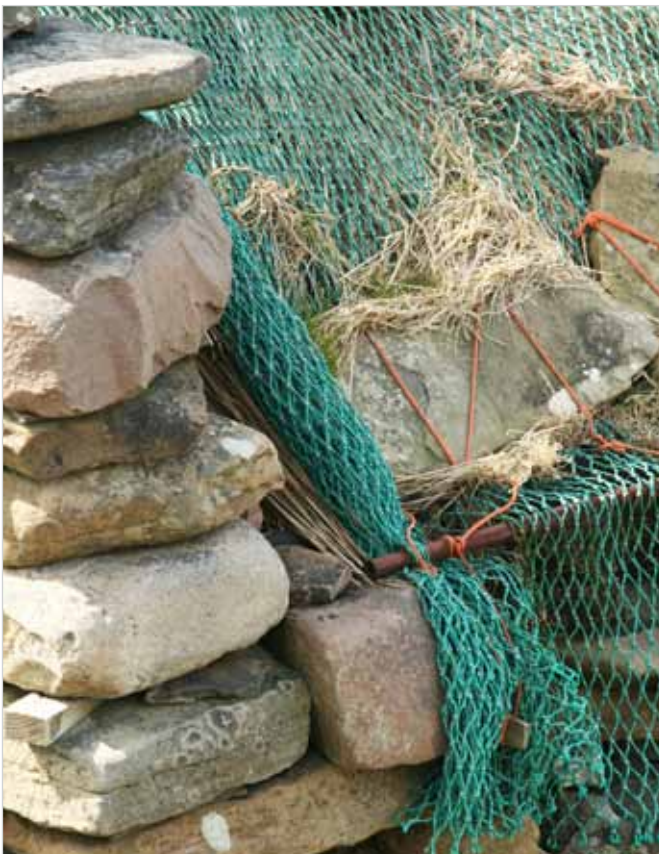
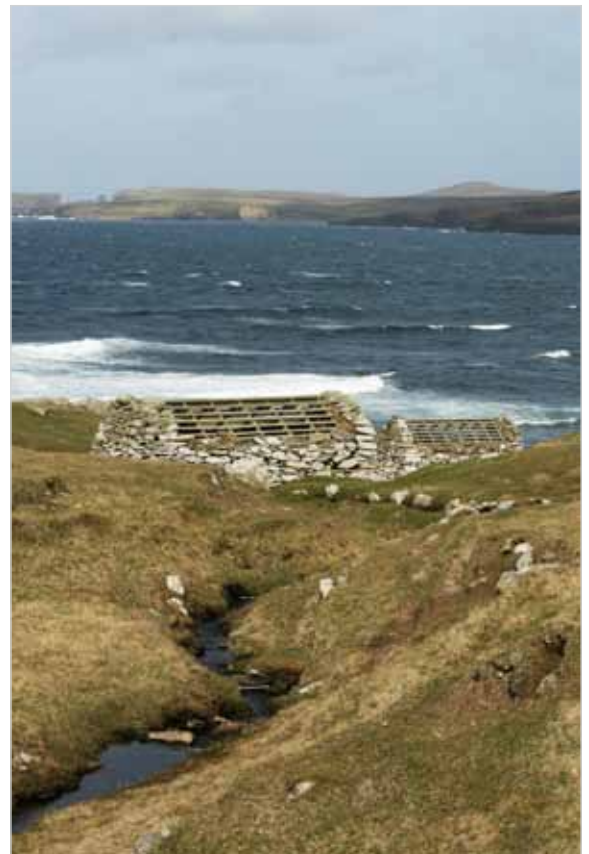
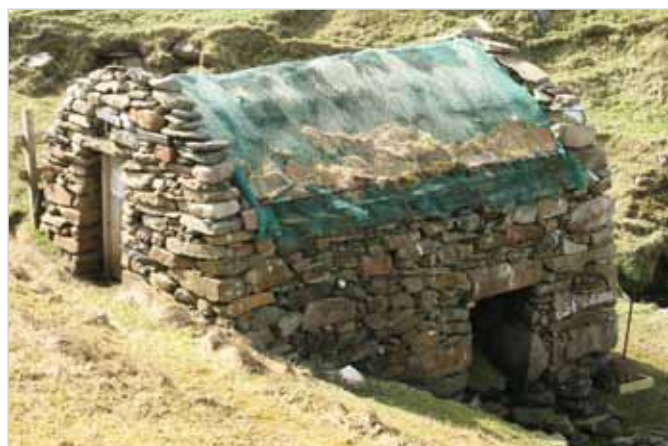
Huxter Mills – Shetland Islands

..... the buildings. Whilst there is visible evidence of thatching material still in situ on the north-west mill building, most

..... of the thatched roof is now missing. Evidence of a turf underlay and straw top coat can be seen. A layer of fishing

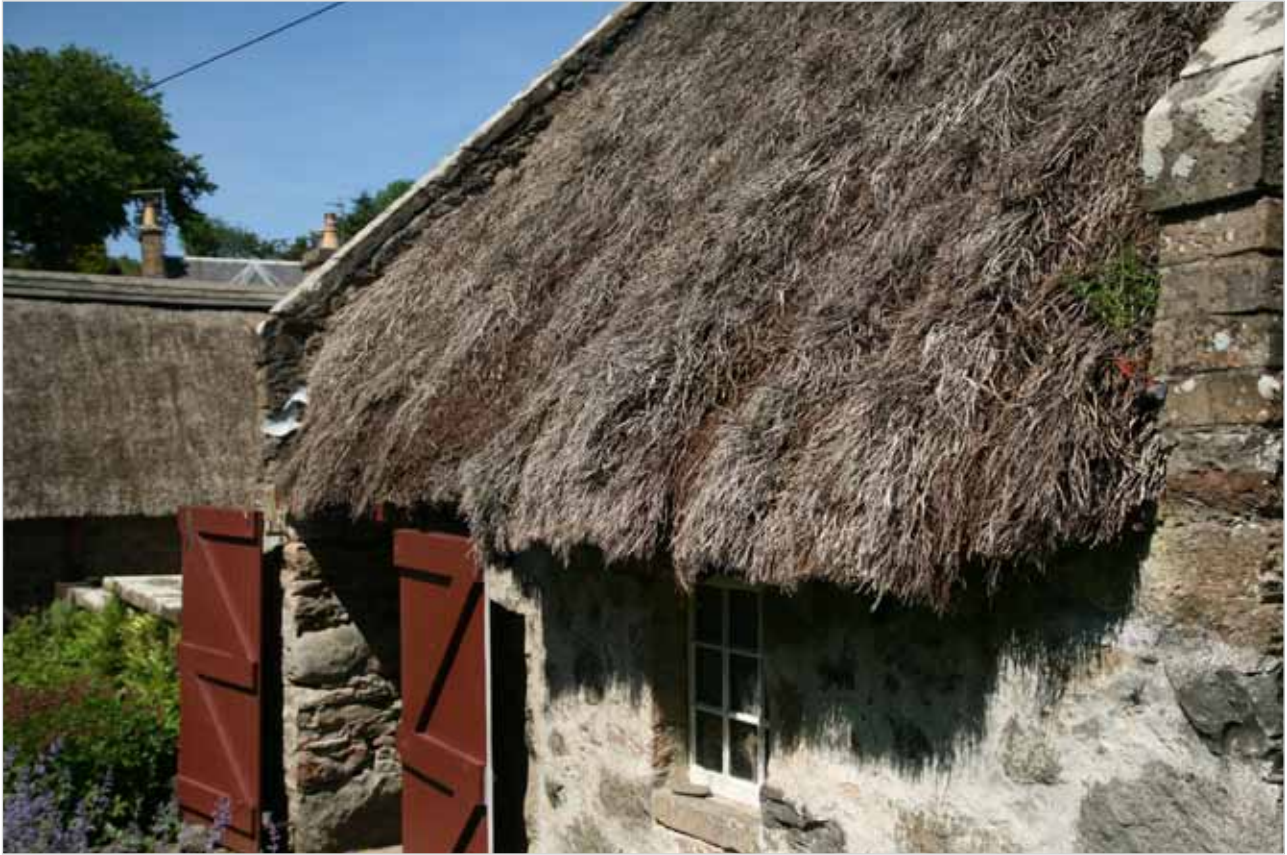
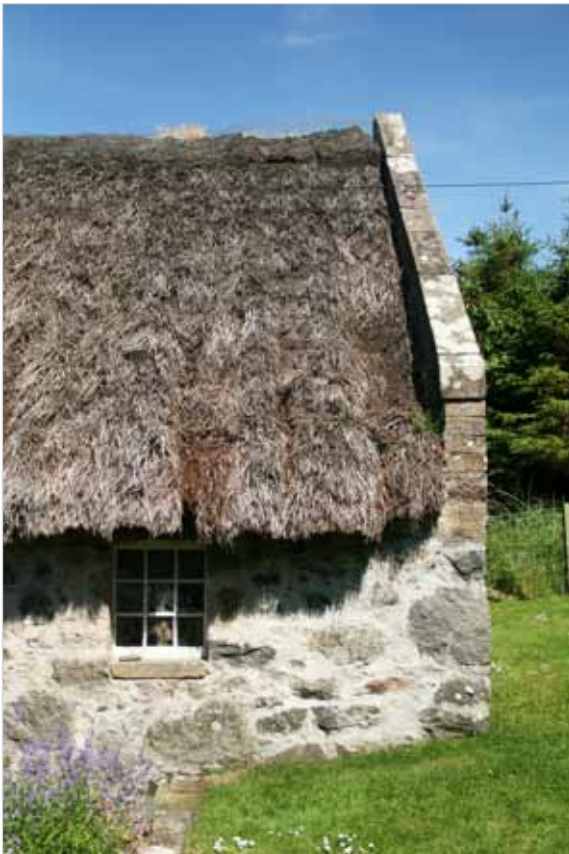
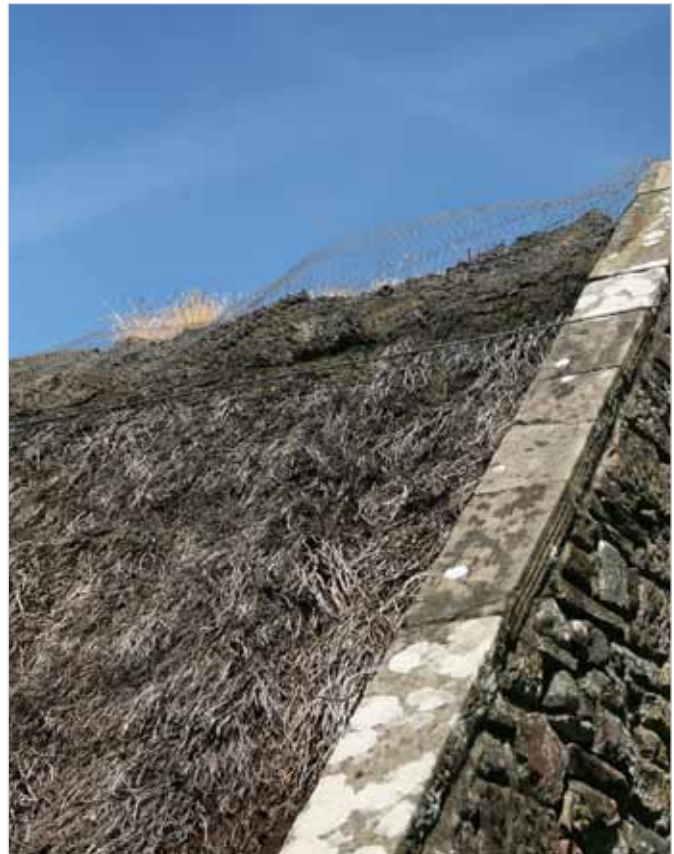
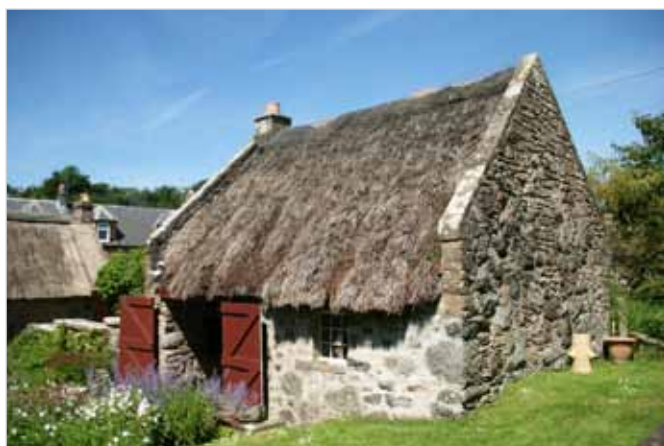
The Ale House – South Ayrshire

Additional Notes: ..... The building known as the 'Ale House' is located in the back garden of the National Trust for Scotland-owned property Souter Johnnie's Cottage. Whilst Souter Johnnie's is listed, there is no mention in the listing description of a cottage in the garden, however, the 'life size figures of Tam O'Shanter', which are currently kept inside the Ale House as part of the museum collection, are mentioned. The Ale House was last thatched in 1998 and currently the heather is in a fairly poor condition. The thatch has apparently deteriorated significantly in the last six months, over the 2013/14 winter period. Patches of heather are missing in places and a few holes have

..... Poor

..... begun to appear in the thatch, exposing the roof structure below. The ridge has also deteriorated significantly, visibly demonstrated by the difference in height between the ridge and the netting. The ridge is netted, whilst the rest of the thatch is left uncovered. The building is due to be re-thatched during the coming year.

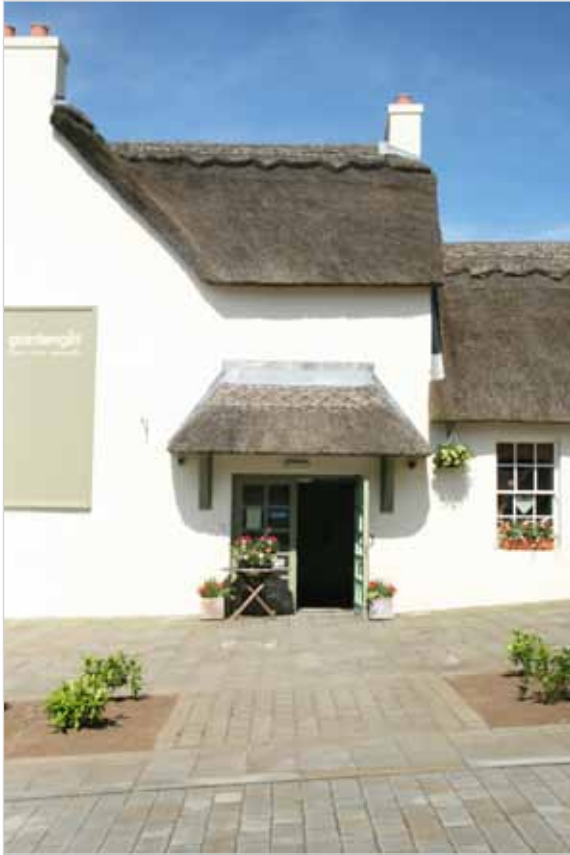
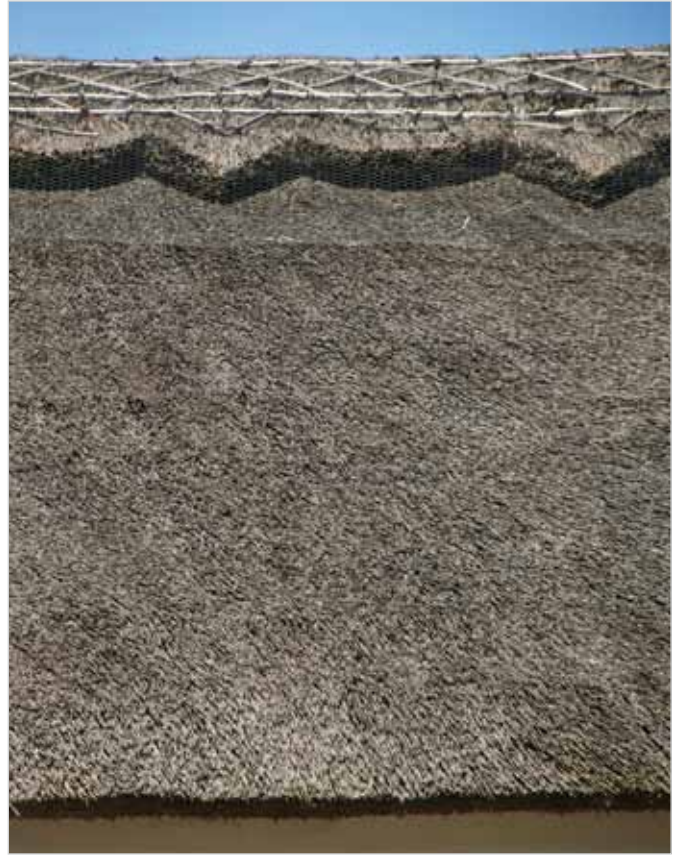
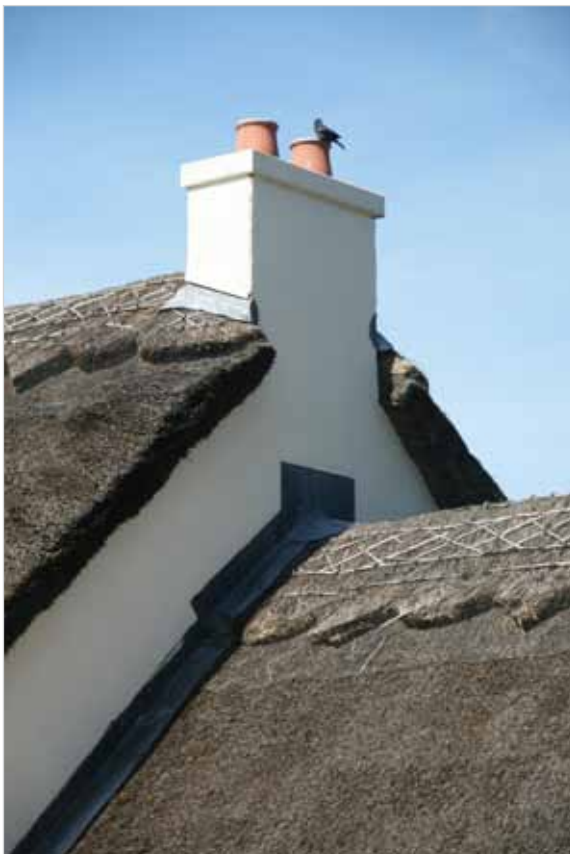
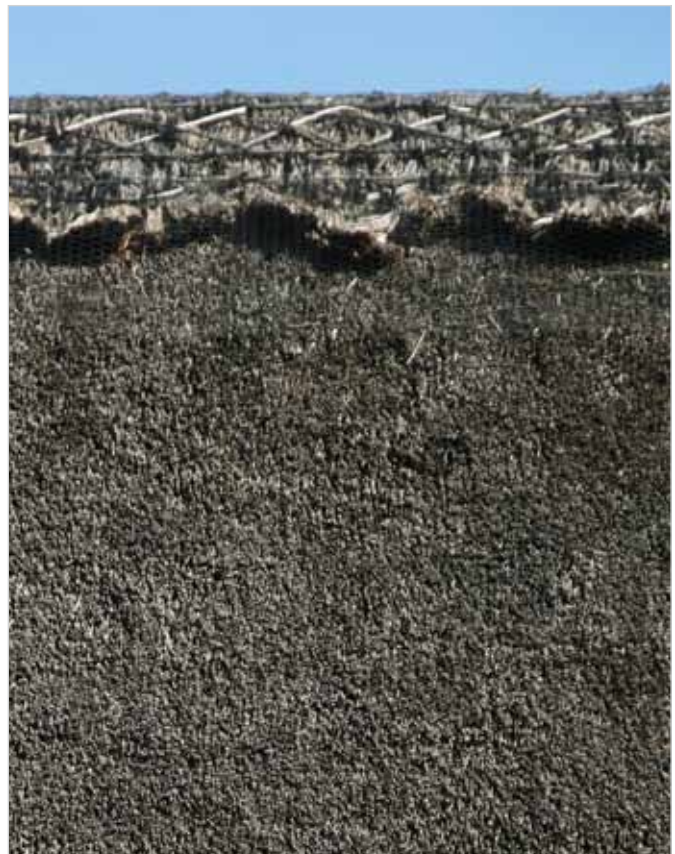
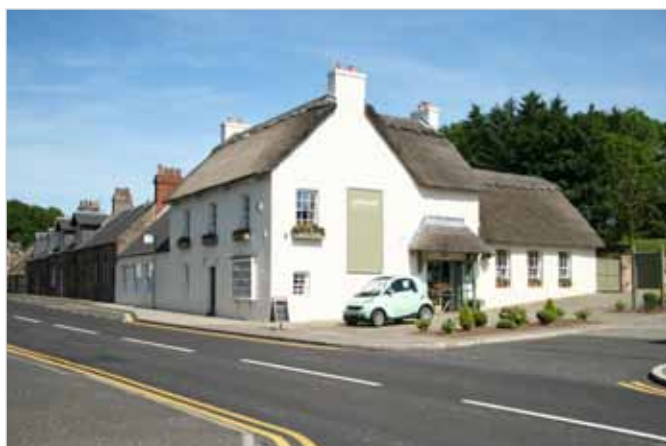
Gardengirl – South Ayrshire

Condition of Thatch: ..... Good

**Additional Notes:** ..... Formerly known as 'Peggy's Tearoom', the building, which is in the same ownership as Souter's Inn (see survey entry 201), is now a garden centre and retail space. According to the owner, the building was last thatched around four years ago (circa 2010). The ridge, and around a foot below the ridge, is netted whilst the rest of the thatch is left uncovered. The ridge is scobed with hazel spars, and is sculpted decoratively along the bottom. Along the north (principal) elevation of the building, the ridge has deteriorated significantly more than anywhere else on the building. The main public entrance is located on the west elevation and has a small thatched canopy above the door opening.
